Hewitt's (2006) Landslide Interruption Epicycles

Atta Abad Landslide, January 22nd, 2010

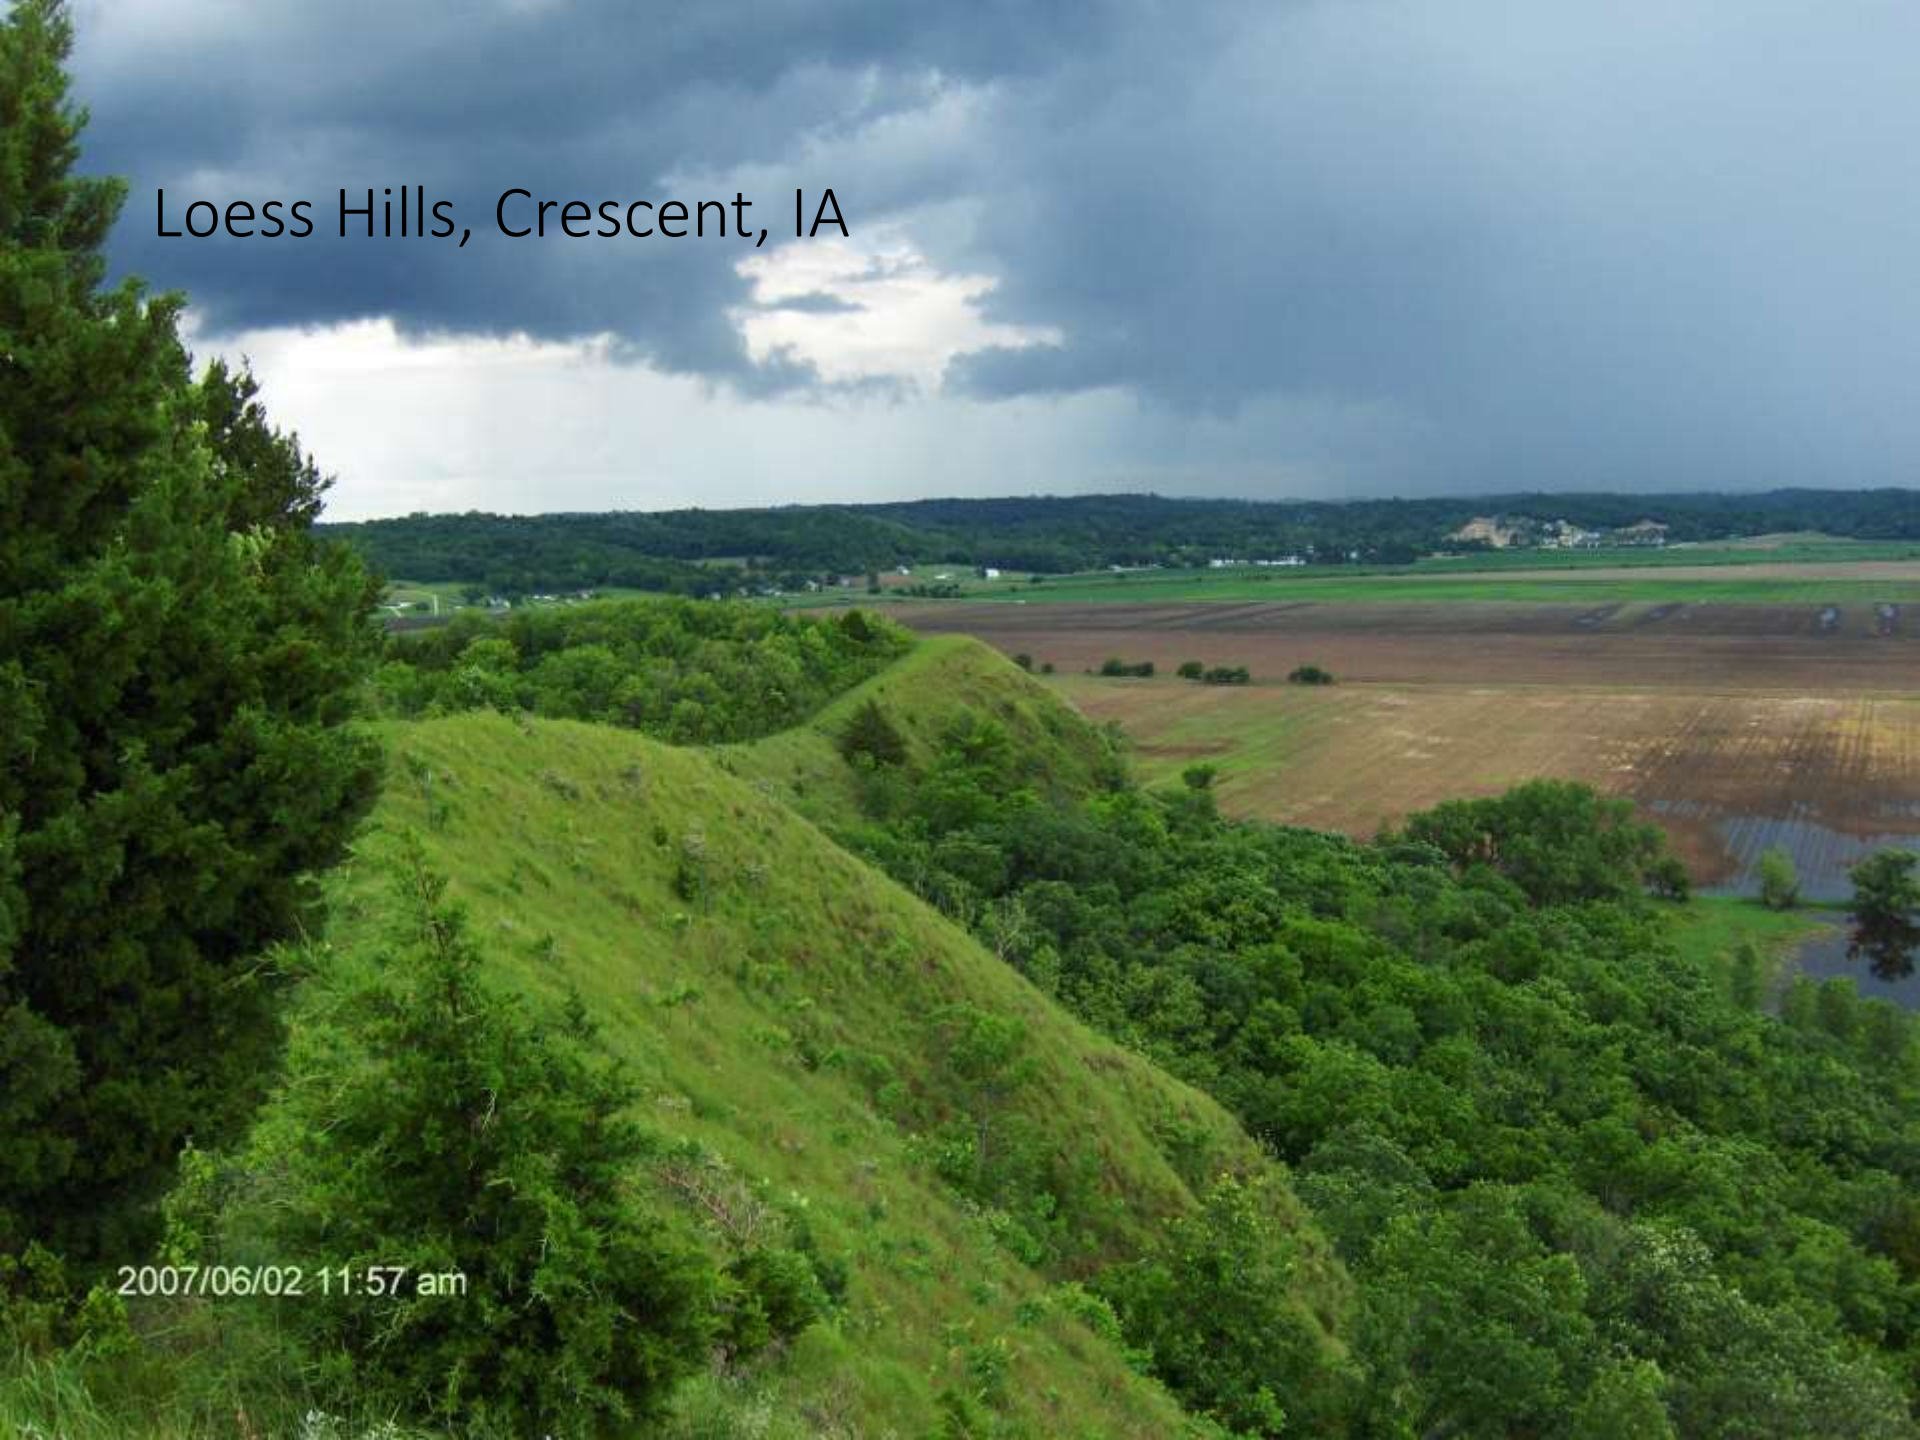
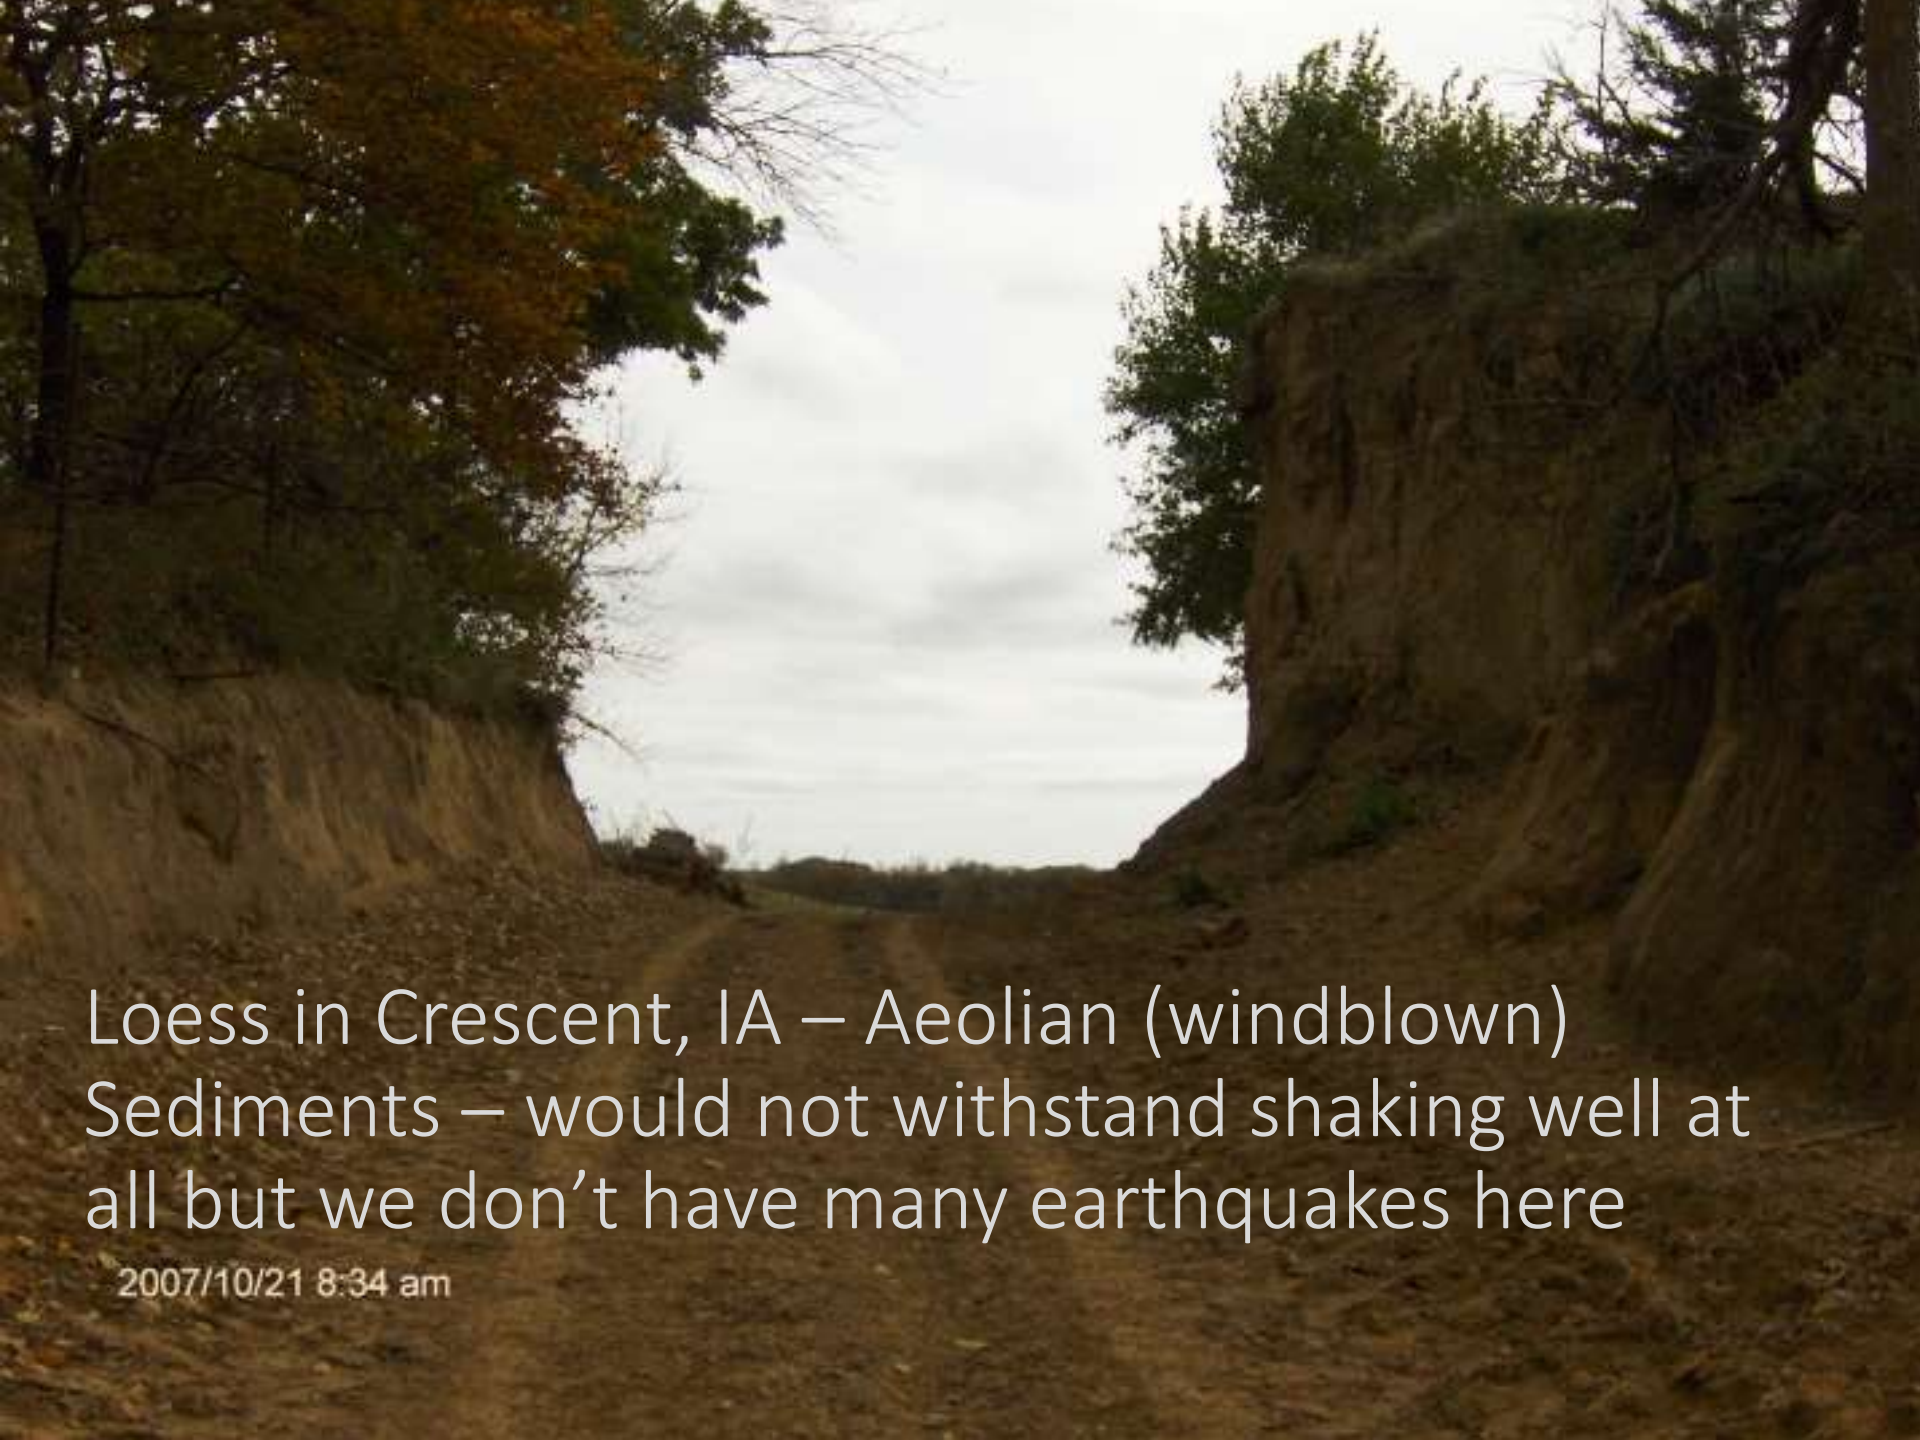
Loess in Crescent, IA – Aeolian (windblown)
Sediments – would not withstand shaking well at
all but we don't have many earthquakes here

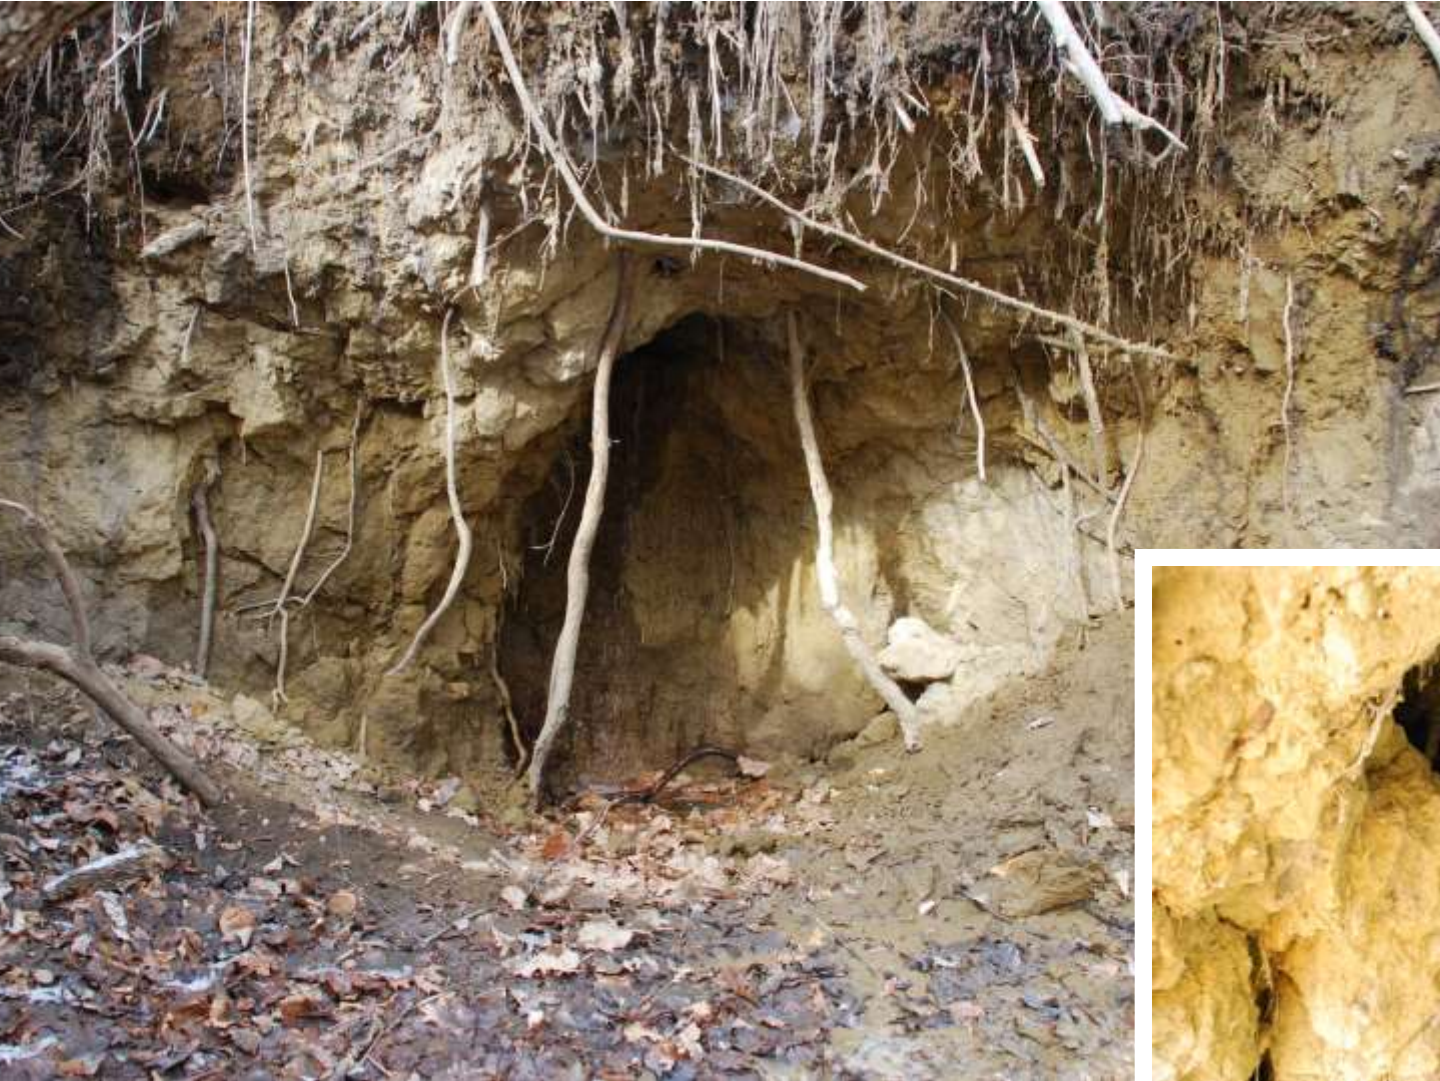
Piping exits
Loess Hills,
Iowa

A photograph of a wooded hillside in the Loess Hills of Iowa. The ground is covered in brown, fallen leaves and some small green plants. Several trees are visible, with their roots exposed and spreading out across the surface of the hill. A large, thick tree trunk is prominent in the center, with its roots spreading out in all directions. In the background, more trees and a clear sky are visible. The text "Piping exits Loess Hills, Iowa" is overlaid on the right side of the image.

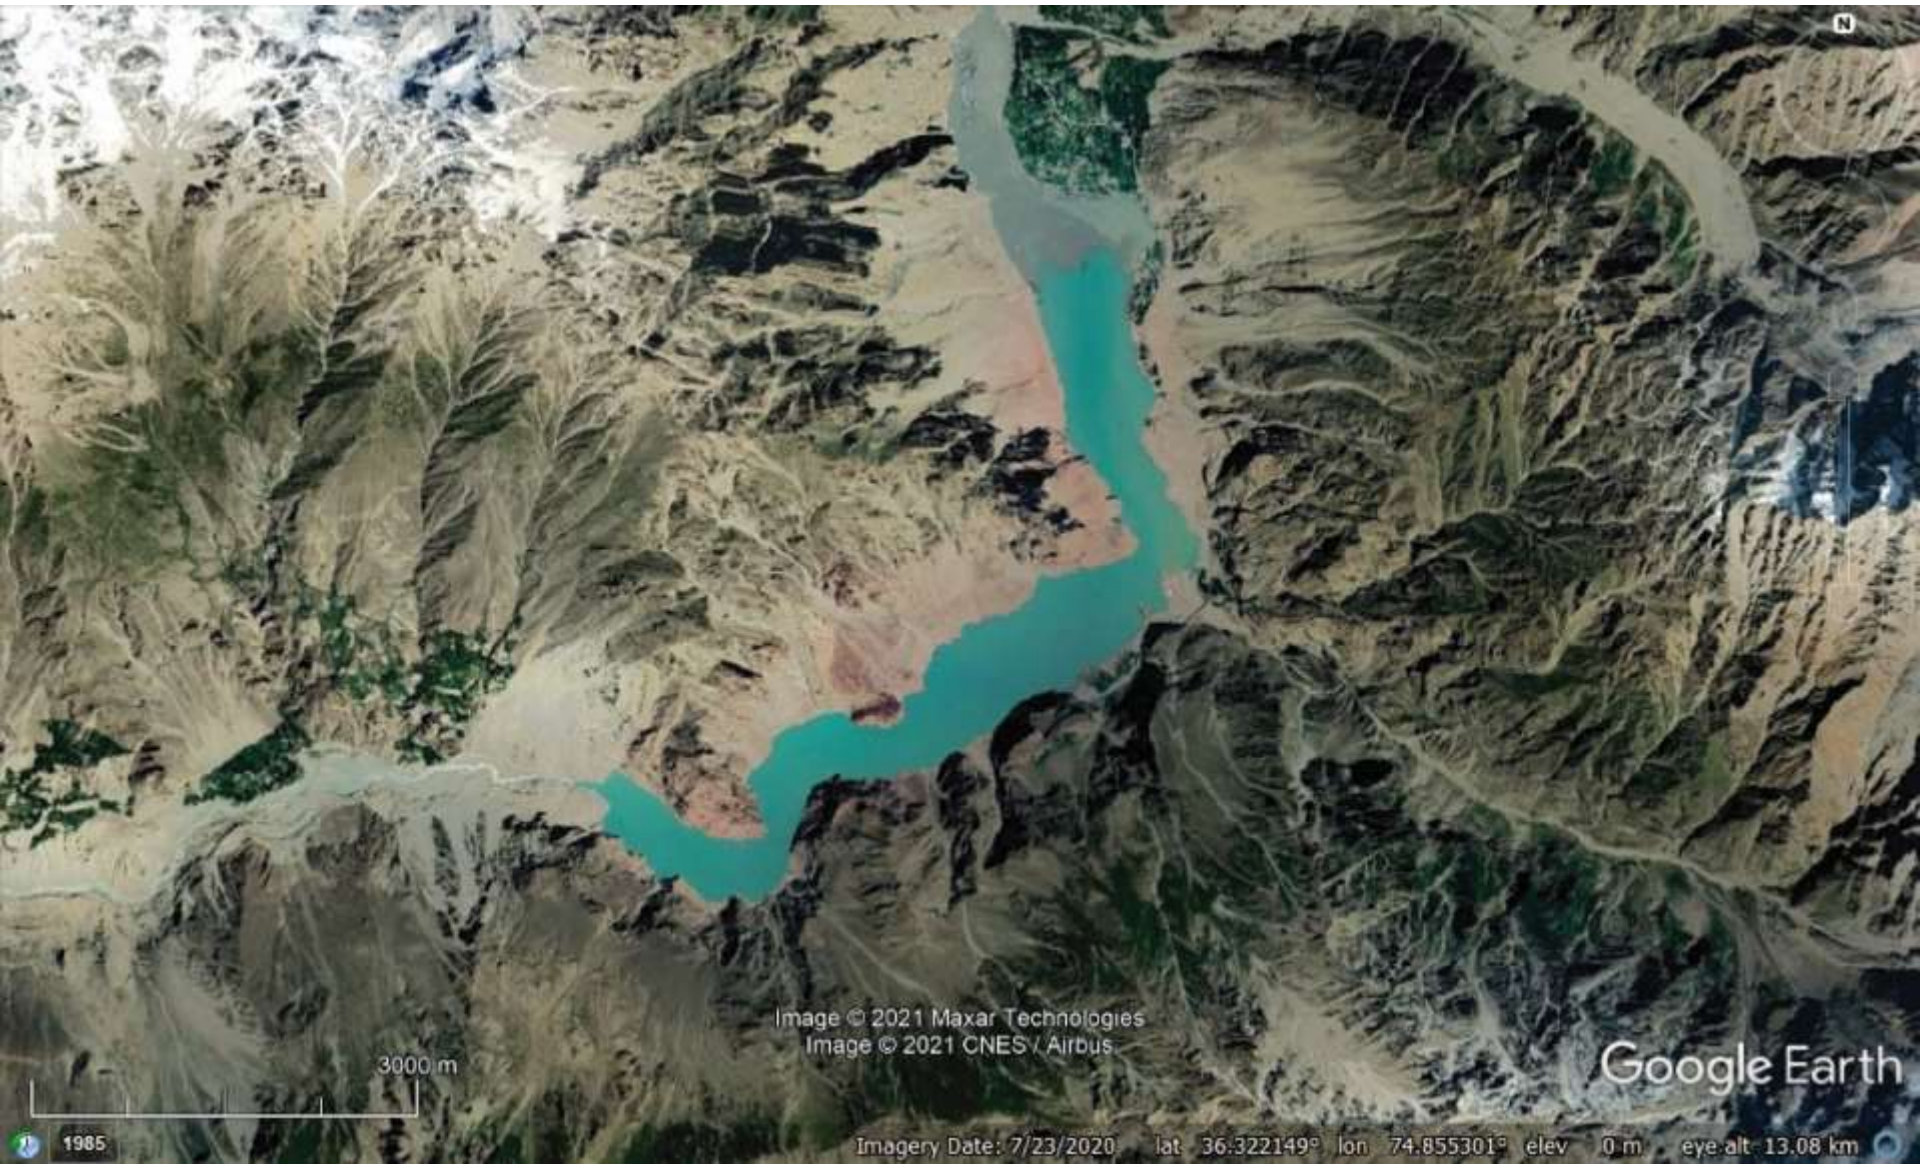
Atta Abad Landslide-dammed Lake

- Buried town of Atta Abad
 - Killed 20 people
- Drowned several towns (Hullehgush, Aina Abad, and several others)
 - Displaced >6,000 people
- Dammed Hunza River
- Large lake impounded
 - ~8 km long lake
- Required large equipment to create spillway
- Blocked Karakoram Hwy (N35) for months
 - Had to rebuild road in several places (buried or drowned portions)
 - >25,000 people stranded
 - Disrupted trade through area, especially between Pakistan and China

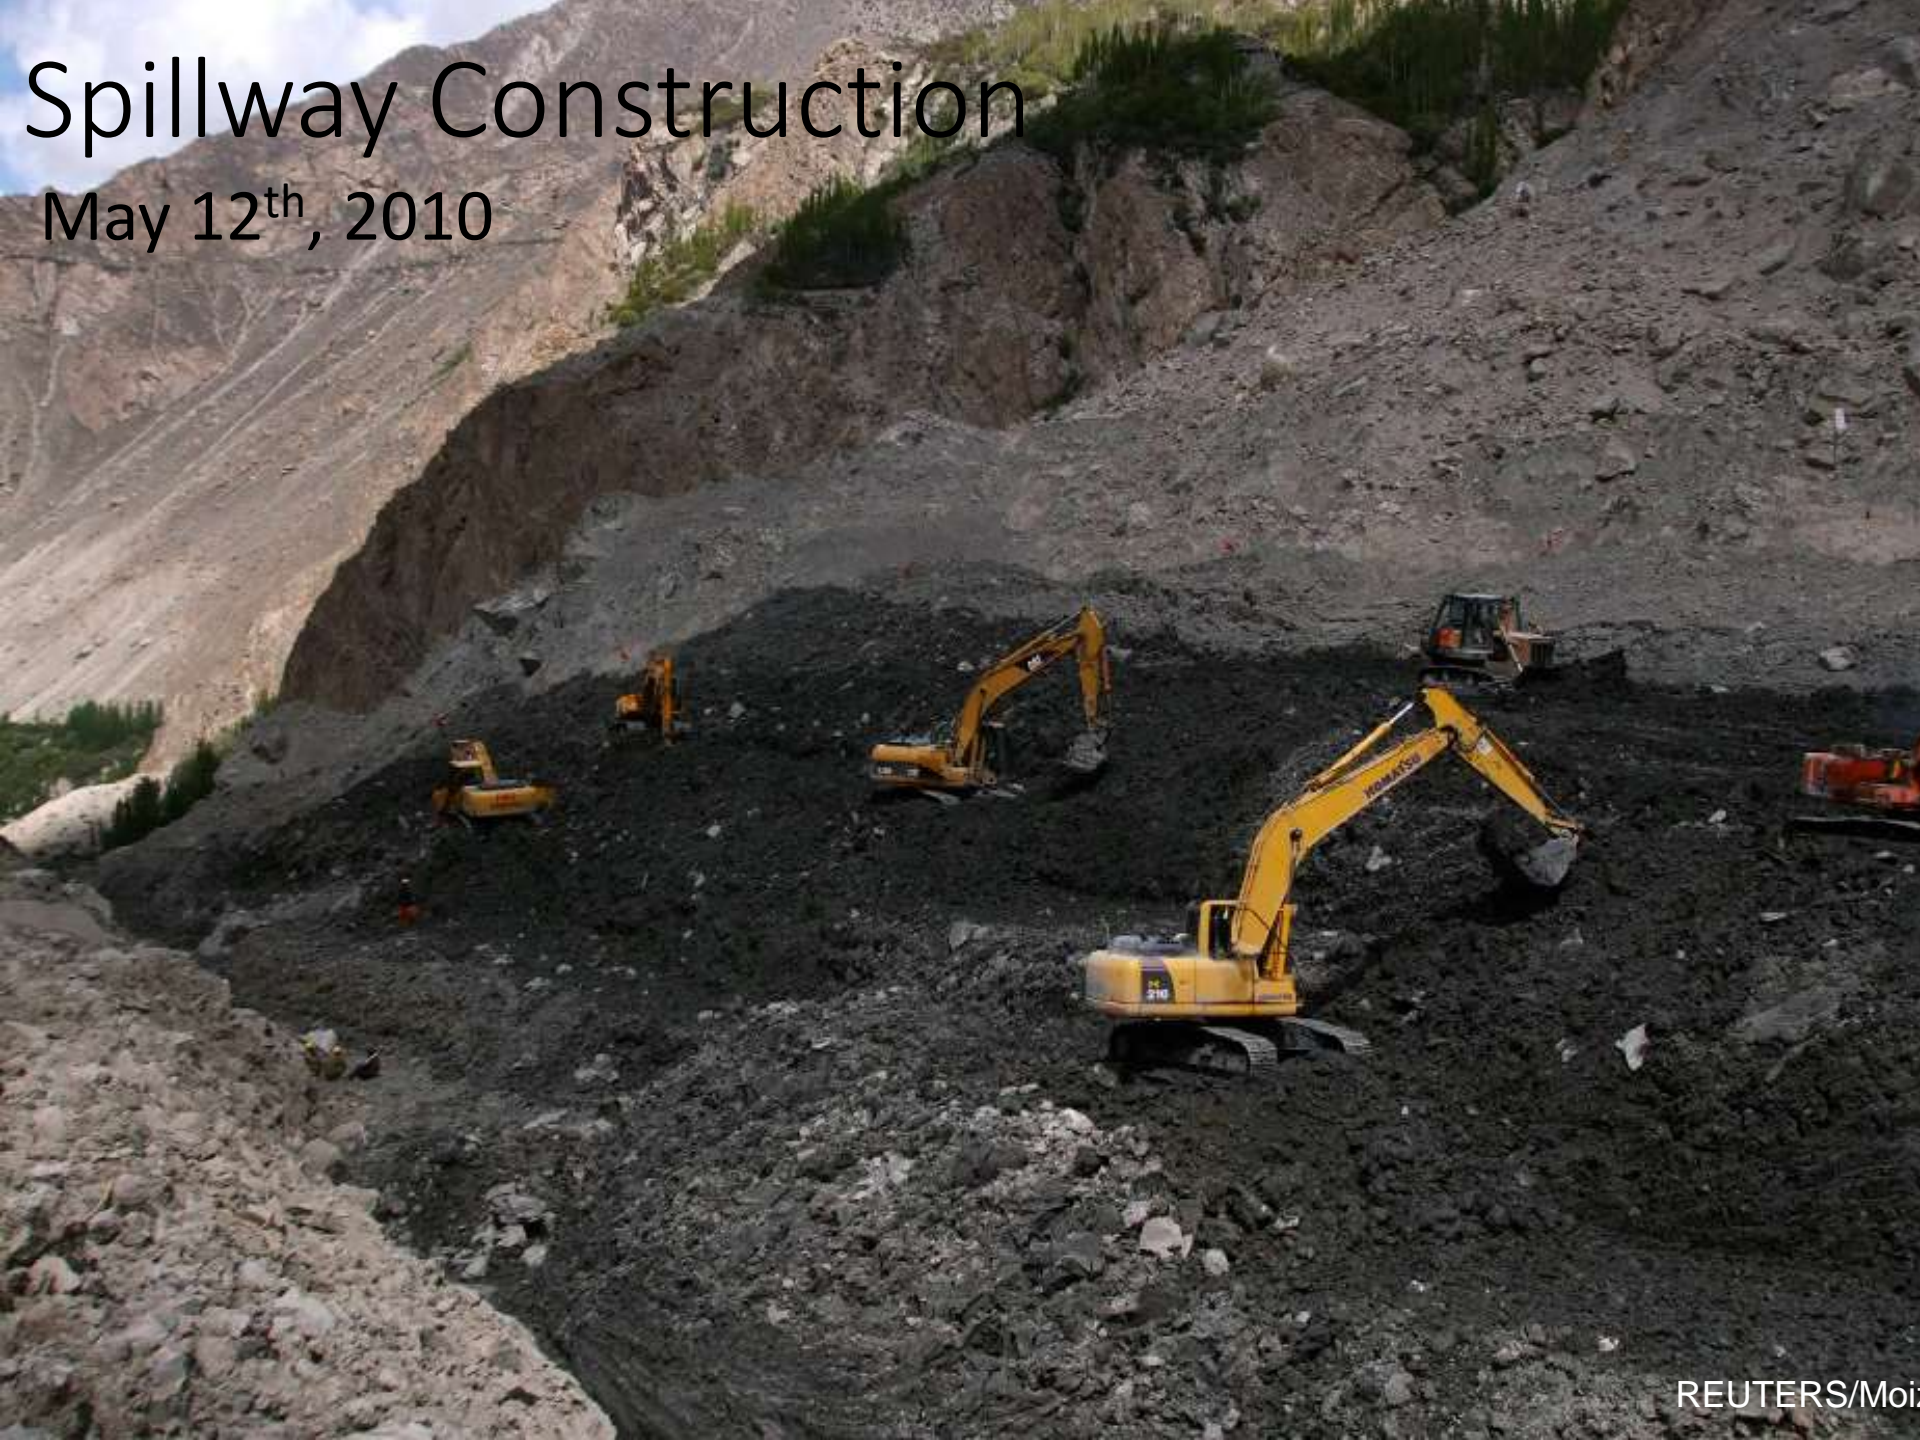
Spillway Construction

May 12th, 2010

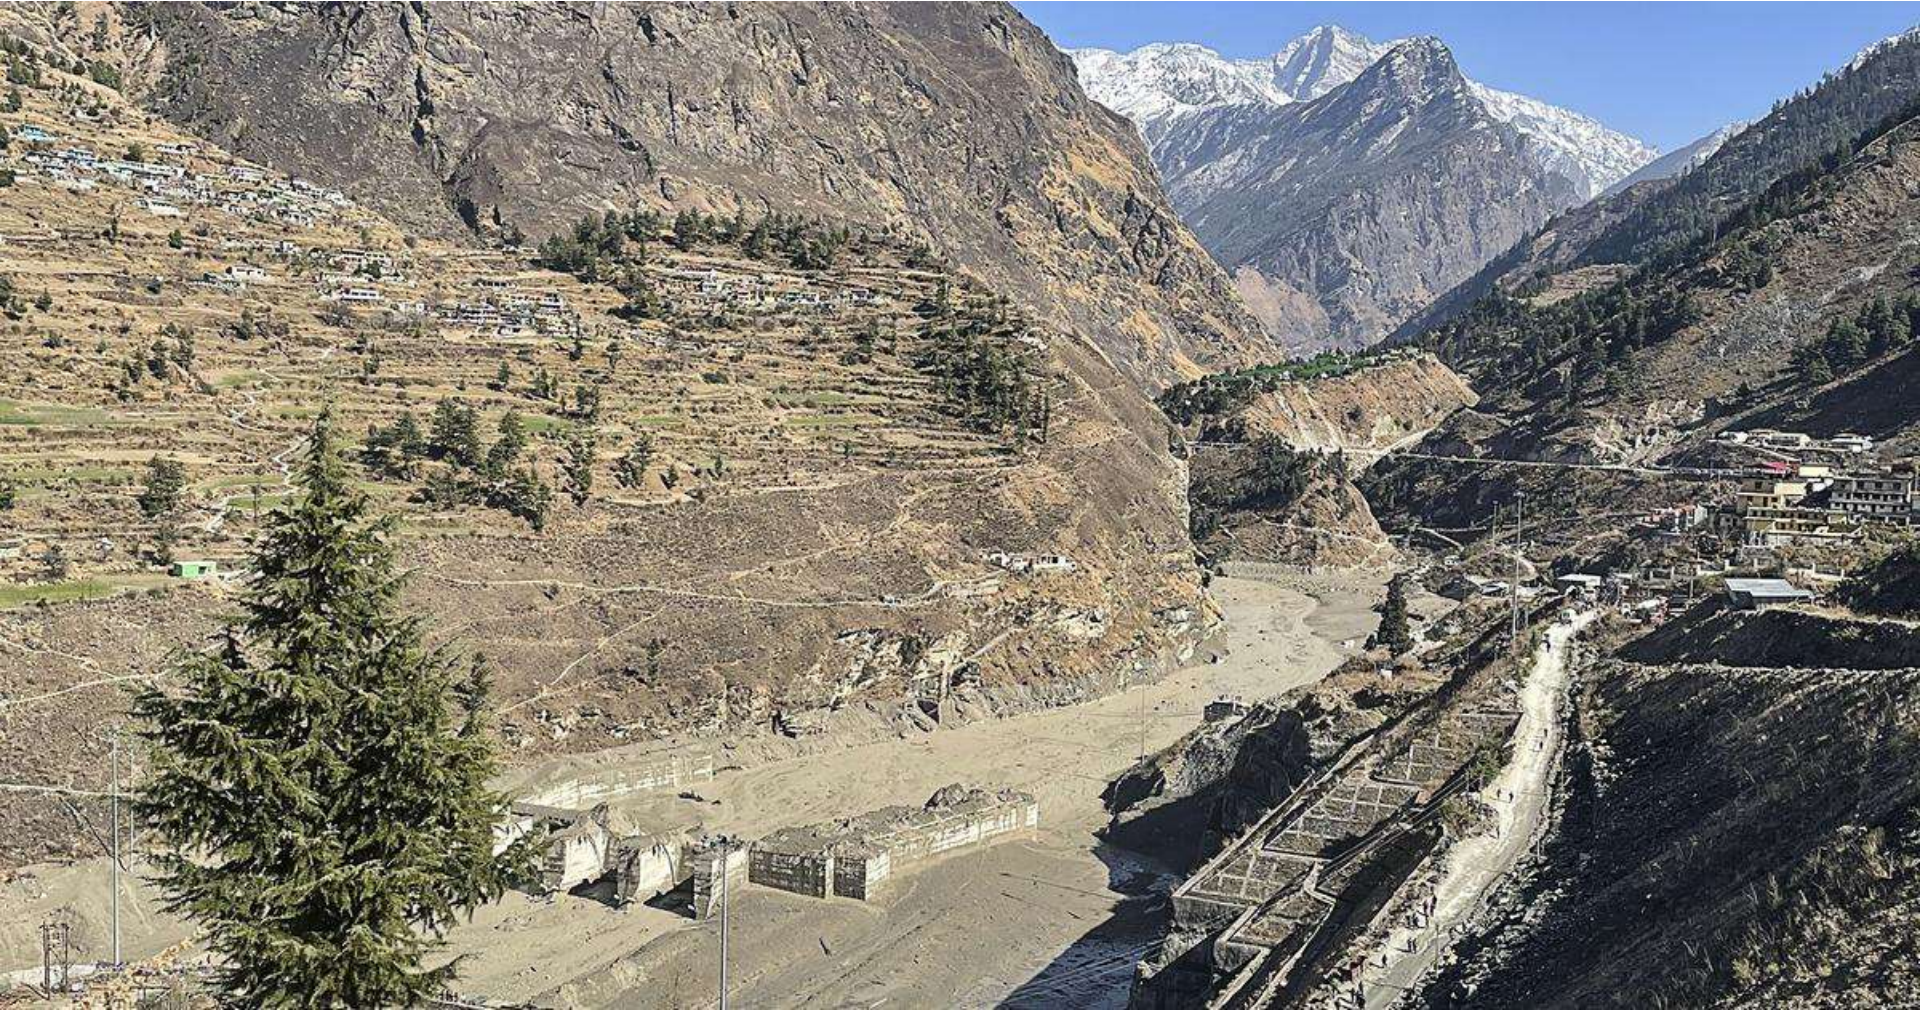
Rishiganga Hydroelectric Project and Dam

- Ice and debris flow from large piece of glacier that broke away
- Rishiganga Hydroelectric Project was building a dam and infrastructure at Reni, India (~300 km NE of New Dehli)
 - Construction began in 2006 (15 years ago)
 - Debris/ice flow destroyed the dam on 2-11-21
- Nearly 200 people missing
- [Video](#)

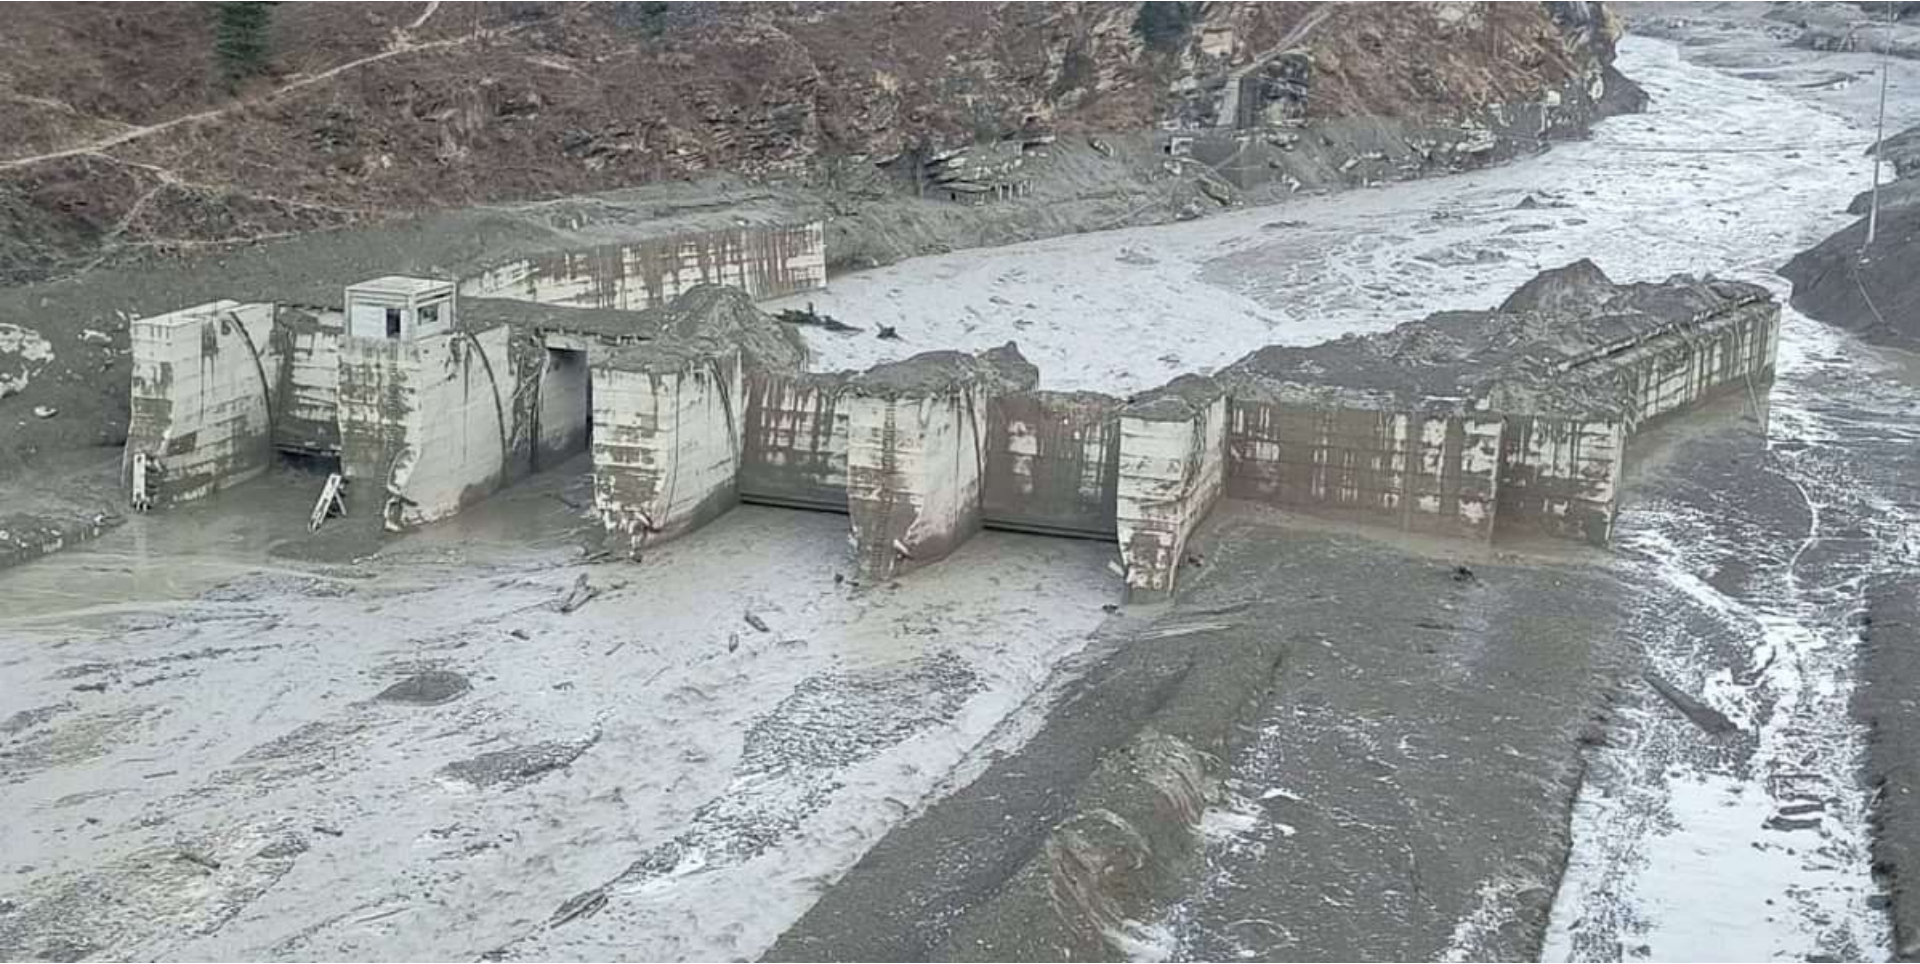
Damaged Dhauliganga hydropower project after a glacier broke off in Joshimath causing a massive flood in the Dhauti Ganga river, in Chamoli district of Uttarakhand, Sunday, Feb. 7, 2021. Photo: PTI; www.thewire.in
